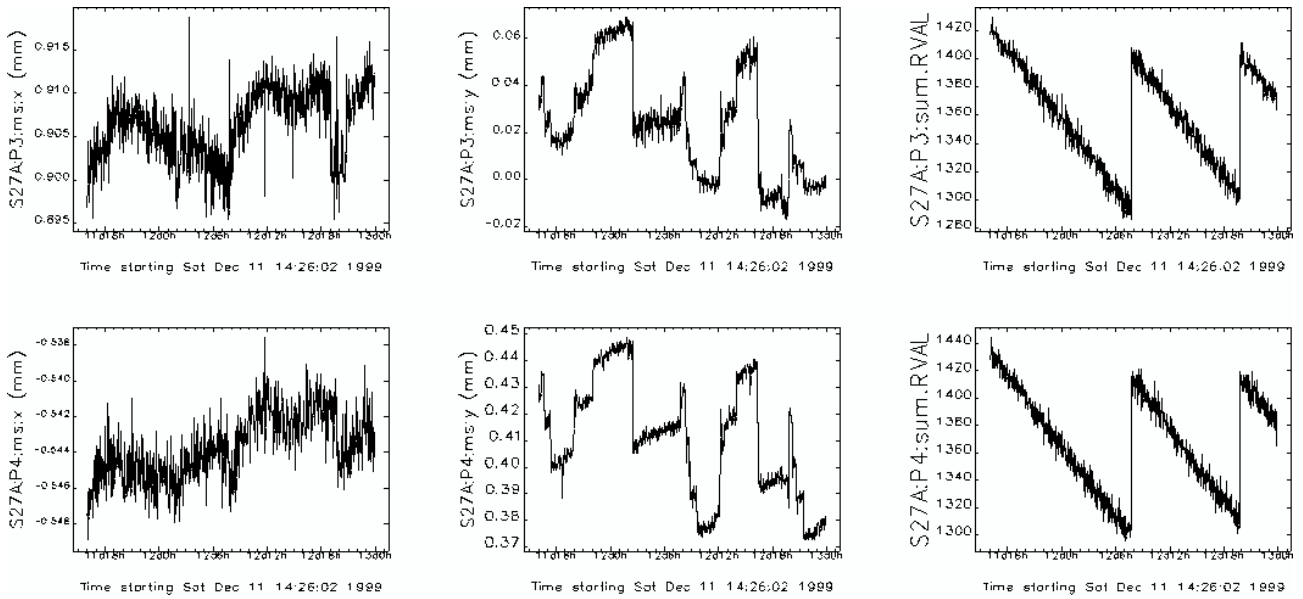
Figure 2: Systematic error measurements that led to the discovery of these TE-like modes. Horizontal position, far left plots; vertical position, center plots; and beam current, far right plots.

Figure 2 illustrates the measurements that led to the discovery that these TE-like modes were corrupting

vertical BPM readings. The curved chamber (section 2) in sector 27 has two BPMs, S27:AP3 and S27:AP4 that are strongly effected by this mode. The beam current is represented in the far right plots labeled “sum RVAL,” which is the sum of four button electrodes. As the beam decays as a function of time, the vertical position shown in the center plots exhibits a step-like function in two different positions along a single section of the curved vacuum chamber. At the same beam charge, the horizontal position does not show the step-like position change. The vertically orientated TE-like modes depend on the stored current and change as the current decays. This might be explained by source points of the TE mode, being heated and cooled as the beam intensity decays.

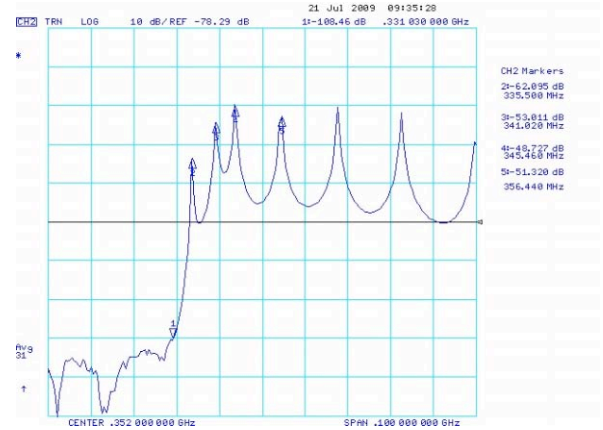
Figure 3: Vacuum chamber rf transmission as built.

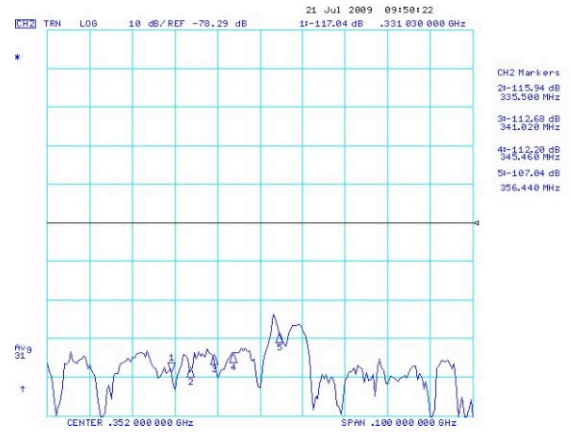
Figure 4: Vacuum chamber rf transmission with three shorts installed in gap area.

The most critical requirement for implementing the mode suppressor is that the shorting device does not intercept the x-ray beam. To determine this, careful ray tracing plots have been generated for each chamber under worst-case steering conditions. The arrangement used for the data in figure 4 violates this requirement and could not be implemented because the short would intercept the x-rays.

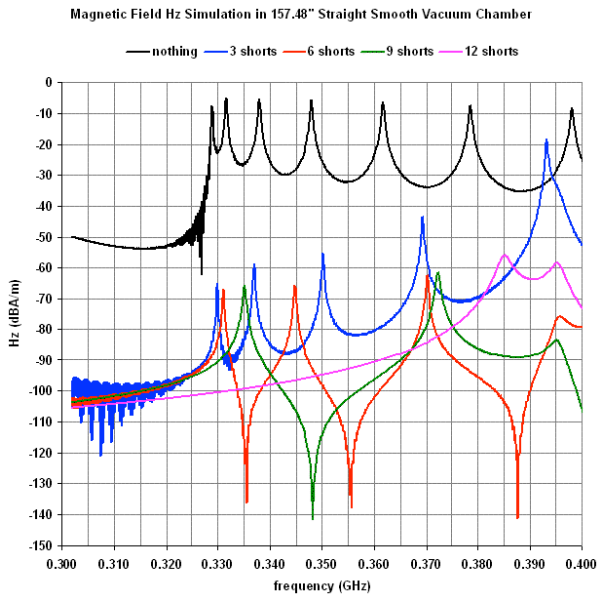
Figure 5: Simulation results without short and with 3, 6, 9, 12 shorts installed in the gap area.

a series of 3, 6, 9 and 12 rf shorts were added in the small gap one inch from the antechamber. The short height was 10-mm which is the same as the small gap between the beam and the antechamber. The first short shown in figure 6 is located 6 inches from the source. The following two snubbers are 12 inches apart. Each new sequence adds 3 additional shorts separated by 12 inches. Figure 5 shows the simulation results without short and with 3, 6, 9, 12 shorts starting from the upstream port. Similar to the bench measurements in figures 3 and 4, the resonances without shorts were suppressed over 50 dB when the small gap was shorted by different numbers of shorts. The more shorts, the greater the resonances were reduced and the higher the cut-off frequency was shifted.

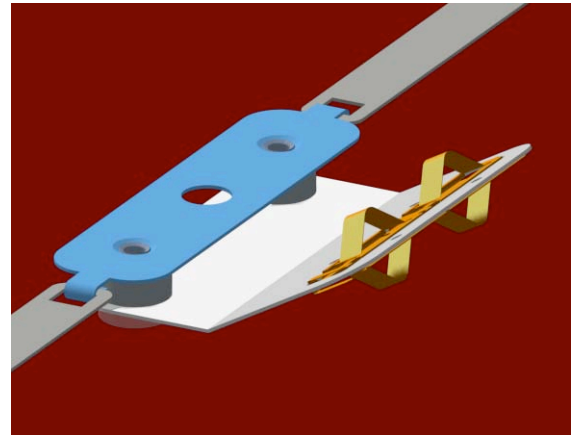
Figure 6: Snubber prototype

The snubber prototypes feature an off-the-shelf longitudinal grounding strip to short the top to bottom of the chamber in the small gap region shown in figure 6. The grounding strip is designed to provide a low impedance path from the top to bottom of the small gap and can be readily inserted into the vacuum chamber. The material is beryllium copper giving it excellent spring features and resistance to compression set. The grounding strips are mounted in stainless steel carriers that can be linked together as shown in figure 7. Installation is similar to that of installing the vacuum chamber getter strips.

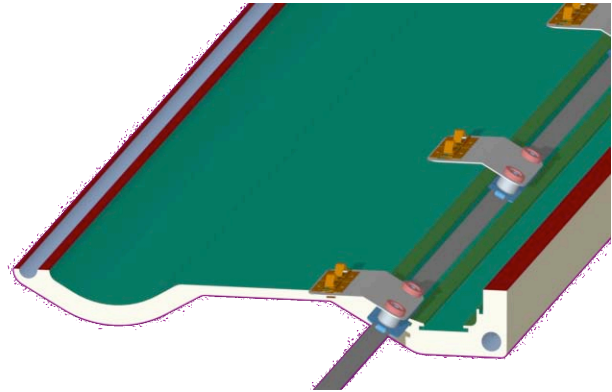
Figure 7: Storage ring vacuum chamber cross section with snubbers installed.

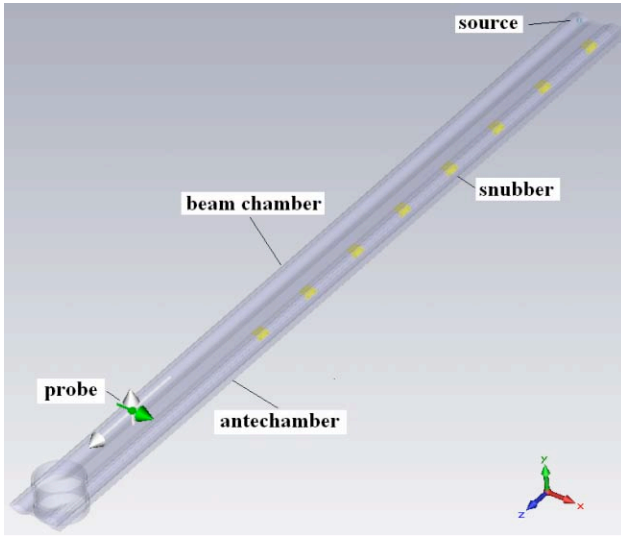
Figure 8: Straight APS vacuum chamber without x-ray absorber and rf screens.

Only eight snubbers can be used on the curved vacuum chamber to avoid x-ray interception. For the convenience of simulation, a straight simplified chamber geometry was assumed. A diagonal 50Ω S-parameter discrete port worked as a source at the upstream port. The adjacent two snubbers were 15.6 inches apart, and the first one started at 6.4 inches away from the upstream port. A vertical cylinder through the chamber was considered, but the x-ray absorber and rf screens installed in this cylinder were ignored. The probes were located at the downstream BPM's position. The simulated structure is shown in figure 8. Figure 9 shows the simulated results for the simplified straight chamber and the measured results in the APS curved chamber without snubbers. The simulated and measured resonances were similar, especially at the ring RF frequency of 351.93 MHz. The difference between the simulation and measurement may come from the simplification of the chamber and snubbers.

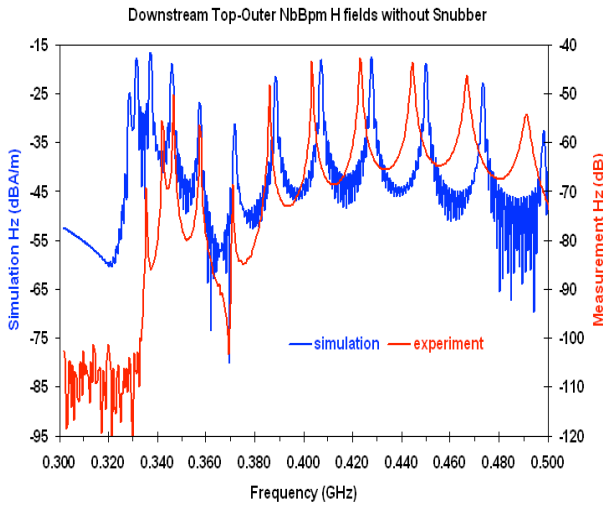
Figure 9: Comparison of the simulated and measured results without snubbers.

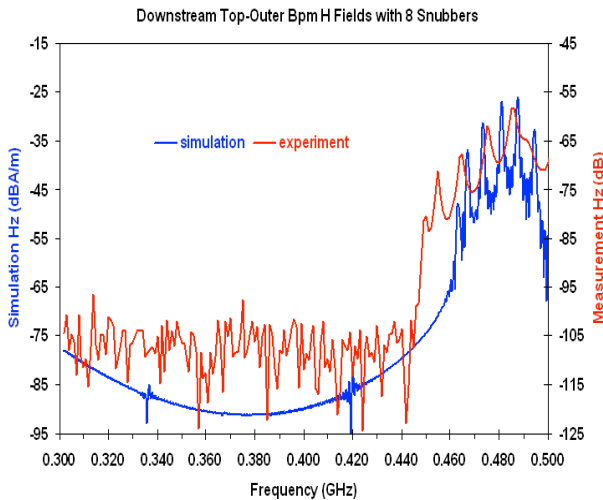
Figure 10 shows the simulated results in a straight simplified chamber and the measured results in the APS curved chamber with 8 snubbers installed. The cut-off frequencies were shifted much higher than the ring rf frequency of 351.93 MHz in both simulation and measurement.

Figure 10: Comparison of the simulated and measured results in with 8 snubbers.
